Advanced Materials Lessen Bird Damage

Carbon composites and titanium alloys strengthen engine blades and casings

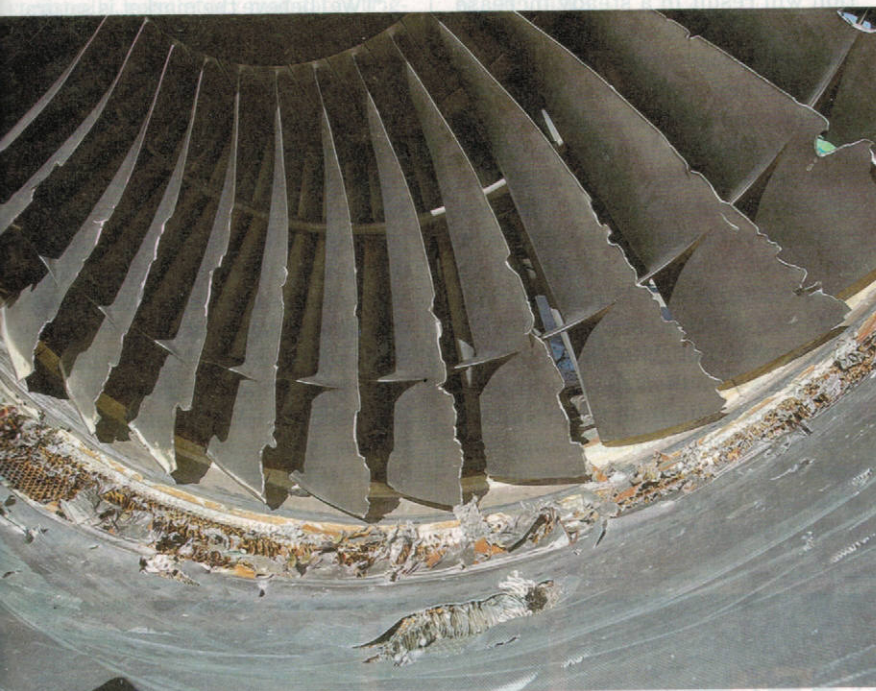
Ingestion of multiple birds damaged this engine on a Delta Air Lines Boeing 757-200 on takeoff from New York’s John F. Kennedy International Airport.

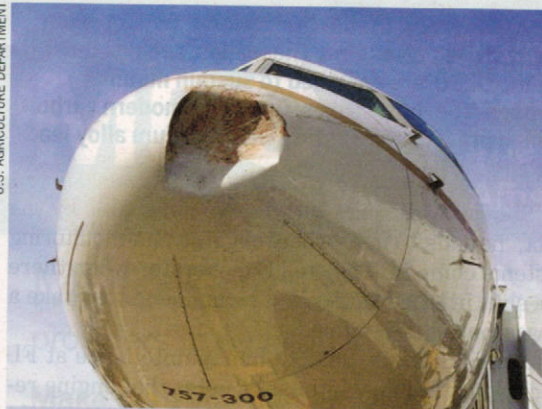
This Boeing 757 struck a bird during climbout from an airport in the Western U.S. The flight crew detected no abnormalities and continued to their destination, where the large dent in the radome was discovered. The aircraft was out of service for 24 hr., and repair costs totaled \$30,000.

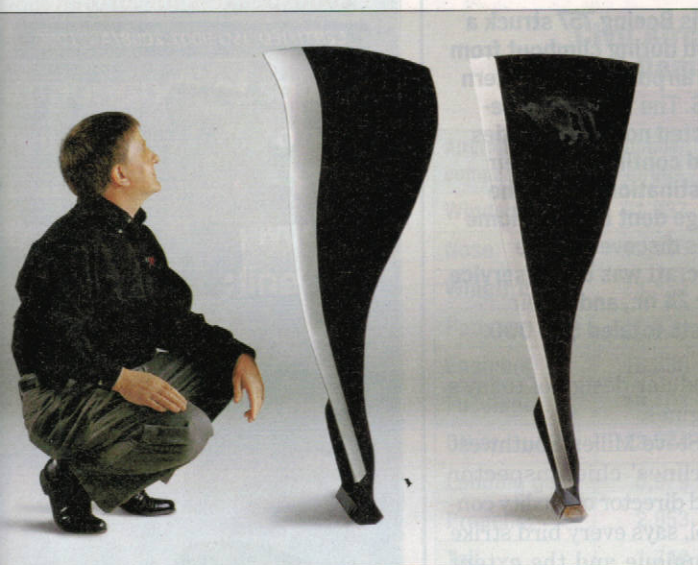
Fan case blades are the first point of impact where a bird strikes an engine. The blades, such as those for the GE90, are designed to sustain minimal damage from bird strikes, thanks to modern carbon composites in combination with titanium alloy leading edges.

ing edges of the blades, are among the major innovations in materials that strengthen blades to better resist bird-strike damage.
